Homestake Mining Company of California

**RE: Homestake Mining Company, Grants Reclamation Project, License Source Materials License SUA-1471, Docket Number 40-8903; NMED Discharge Permit DP-200: 15-Day/30-Day Corrective Action Report for the Unauthorized Discharge from Clarifier #2 Blowdown Pump**

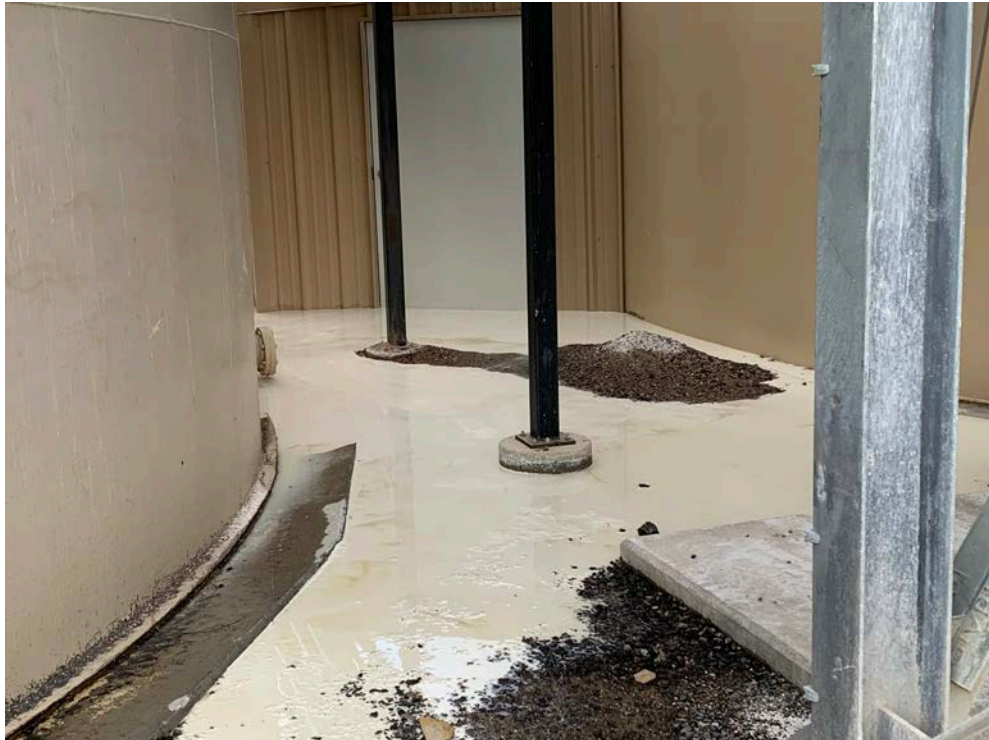
Upon arriving at the Reverse Osmosis Water Treatment Plant (RO WTP) on Friday morning (March 27<sup>th</sup>), workers immediately noticed the release of sludge from the clarifier. Further inspection showed that the sludge was being released through the blowdown pump seal. This seal is the same one that failed in September 2019. At that time, HMC ordered replacement parts and received a generic part which was installed since original equipment parts were not available for several weeks. This generic seal is the one that failed. It should be noted that the sludge release was limited to the site adjacent to the clarifier and did not migrate offsite.

The failure resulted in the release of approximately 3-4 cubic yards of sludge consisting of spent lime from clarifier #2 (see photographs). The release occurred immediately adjacent to the clarifier, was contained onsite, and was cordoned off by site personnel pending remediation efforts. Sludge concentrations were estimated from existing data from sludge samples collected in the collection ponds. The pond samples exhibited a uranium concentration of 3,090 milligrams/kilogram, radium 226 concentration of 0.3 picoCuries/gram-dry (pCi/g-dry), and thorium 230 concentration of 0.3 pCi/g-dry.

**Photograph 1 showing sludge release adjacent to Clarifier #2**

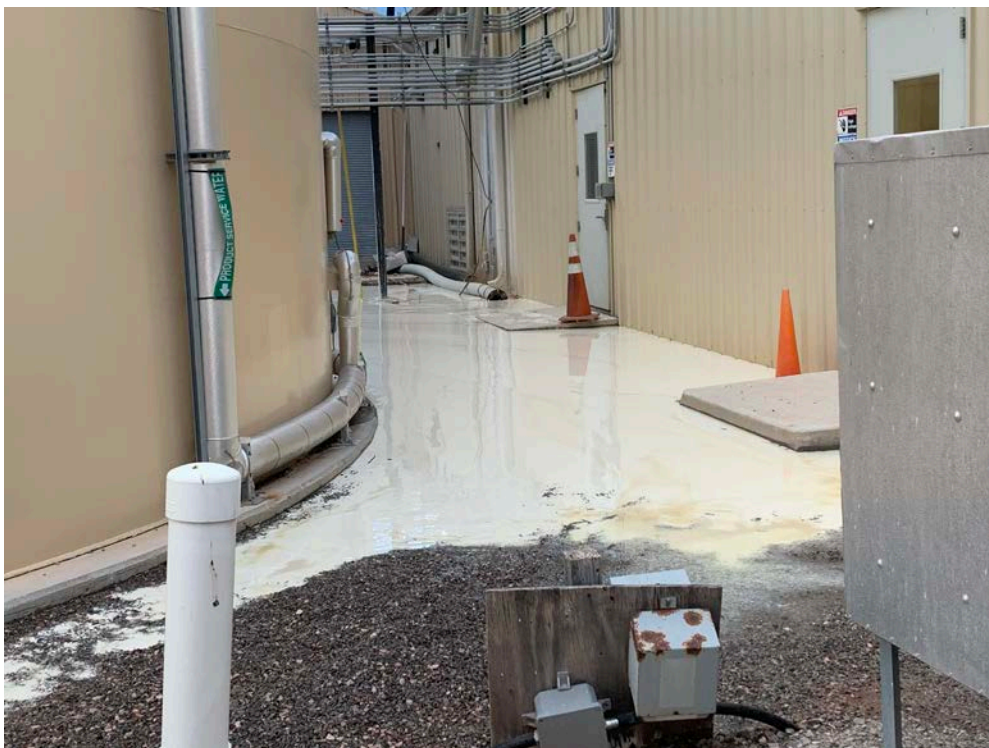
**Photograph 2 showing another view of sludge release adjacent to Clarifier #2**

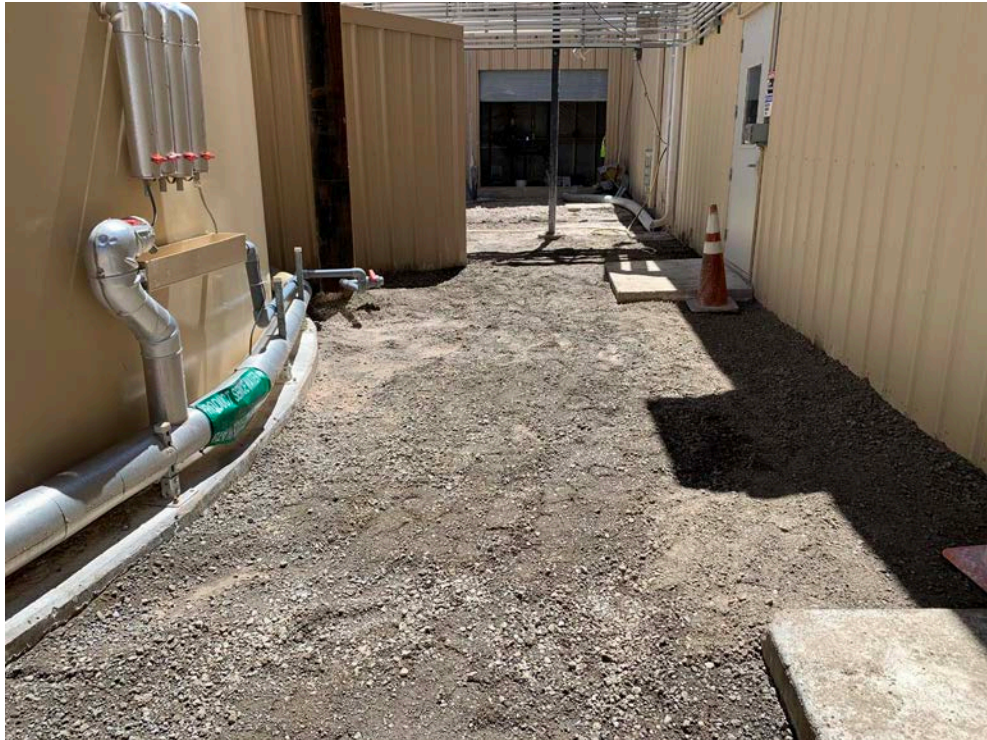
**Photograph 3 showing similar view as Photograph #2 after cleanup of sludge release**

*RE: 15/30-Day Notification of Unauthorized Discharge from Clarifier #2 Blowdown Pump*  
employees. Prior to other employees returning to work, HMC provided COVID-19 testing to non-symptomatic employees and performed a hyper-cleaning of the office and RO WTP control room. On April 9<sup>th</sup>, a contractor was brought in to perform the work. The work was performed under a radiation work permit (RWP) overseen by site personnel. The sludge was loaded into a front-end loader by hand for disposal in Evaporation Pond #1 (EP-1). In addition to the sludge removal, underlying impacted soil and gravel cover was over-excavated and placed into EP-1 along with the sludge. An estimated total of 8-10 cubic yards of material was removed and placed into EP-1 and the area was redressed with imported material and fresh gravel. Photographs showing the area after remediation are attached.

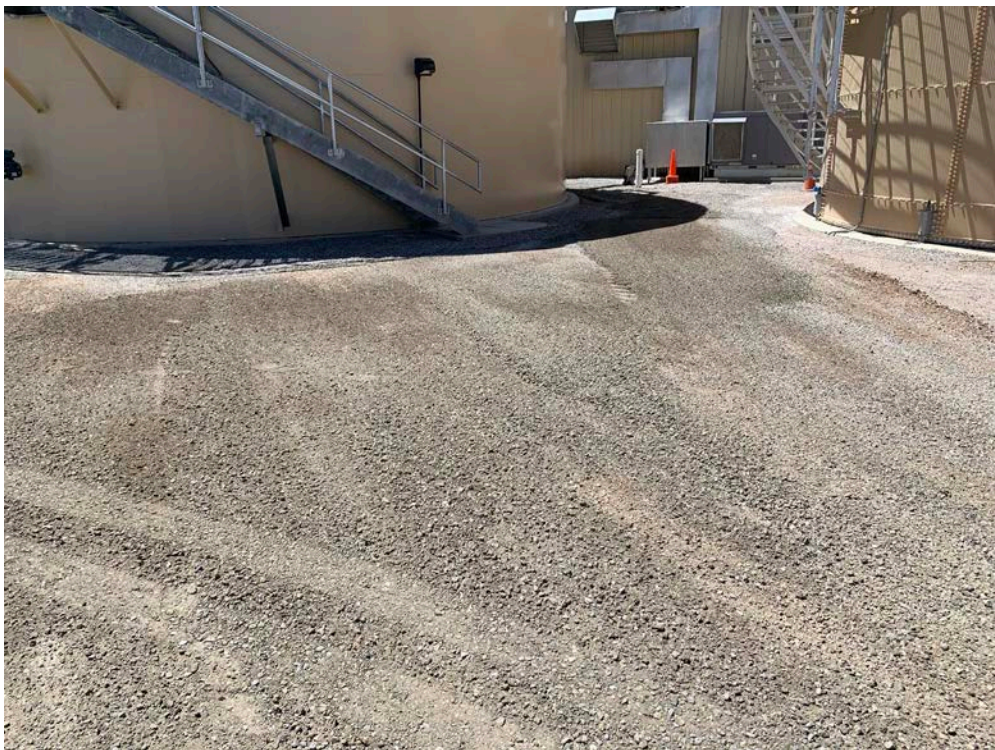
**Photograph 4 showing another view of area after sludge cleanup**
